■ Valve Seat and Guide: Insertion Monitoring

AN184

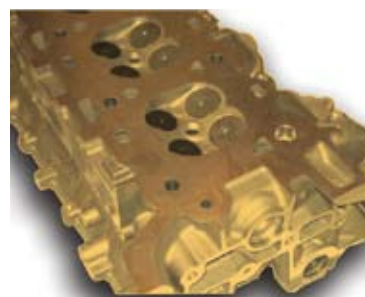
Due to the quality spills the manufacturer was experiencing, it became apparent that they needed to augment their existing method of window analysis to better detect valve seat and guide defects. They required a press monitoring system that would identify even the most subtle defects in their head seat press production. Upon evaluating options the manufacturer decided to implement a Sciometric Multi-Ram Press Monitoring System. They chose the system based on its advanced defect detection capability. The core technology uses algorithms designed specifically for valve seat and guide applications. The system evaluates the entire force-distance test waveform to identify anomalies of features unique to press applications. In addition to unseated seat issues the manufacturer required consistent and reliable detection of other valve seat and guide defects such as: bad seats, pockets or guides, reversed seats, missing seats and improper seat or valve pocket size. Based on the flexibility of the system and its embedded valve seat and guide intelligence, the manufacturer was able to detect even the smallest press defects that were previously processed as false accepts by their traditional monitoring methods.

The manufacturer upgraded the system to include QualityWorX® as a mechanism to archive full press waveforms for each insertion. The birth history and traceability functionality of the system appealed to them as it would enable them to demonstrate each part's adherence to specifications. Using the failure pareto detail provided by the system the manufacturer was also able to identify and fix key problem areas in their head cylinder production line.
