ASSEMBLY VERIFICATION USING FORCE MONITORING KEY FEATURES

SCIOMETRIC POWERTRAIN SOLUTIONS

AN151, Rev2 Aug 11 | © 2003-2011 Sciometric Instruments Inc.

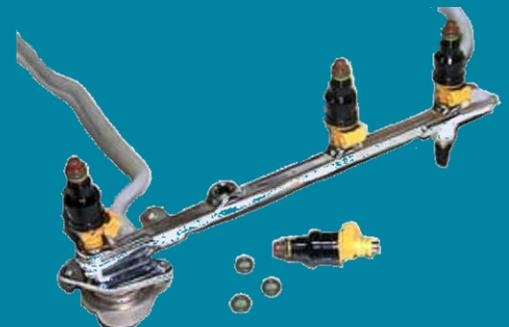
A Sciometric process monitoring system using signature analysis addressed the requirement. In the test, each press head is coupled to the ram by a spring, and its position is monitored using an LVDT (Linear Variable Displacement Transformer) with load cells also monitoring the insertion force. A PLC (Programmable Logic Controller) controls the air cylinders. The system quickly generates and displays a profile of insertion force versus time, determines the maximum force applied and the total mechanical work done during the insertion process. A missing O-ring is indicated if the results of the total work done are too low. If it is too high, it indicates high friction in the press process, which could be from a pinched or rolled O-ring or abrasive contamination in the fuel rail pump. The maximum press force is a key indicator of defective injectors. If the press force is greater than a present limit, it is likely that the fuel injector is defective. A high starting force indicates that the fuel injector is misaligned, which could greatly damage the O-ring. When the press is in motion and a low force is indicated, this means that the O-ring is missing or undersized; if it is too high, the O-ring may be caught in the press.

Once the fuel injector has been inserted and the retaining clip is in position, the system records the LVDT reading and the ram is then withdrawn. The new LVDT reading is compared with the previous one and if the fuel injector is properly engaged, the press head remains in position. The spring allows the ram to be withdrawn and the LVDT reading does not change. If the clip is not engaged, the injector is withdrawn by $\frac{1}{4}$ inch and the LVDT reading changes, which causes a failure indication. The test and analysis system alerts the operator of the failure mode in real-time and makes 100% inspection reliable and practical.
